MEVOTECH INSIDER
Service Tips and Best Practices

Correct Installation Orientation: 2003-1989 Acura and Honda Front Upper Ball Joint

Brand	Supreme	Product	Ball Joint	Date	November 2022
Part Number(s)	MK90336

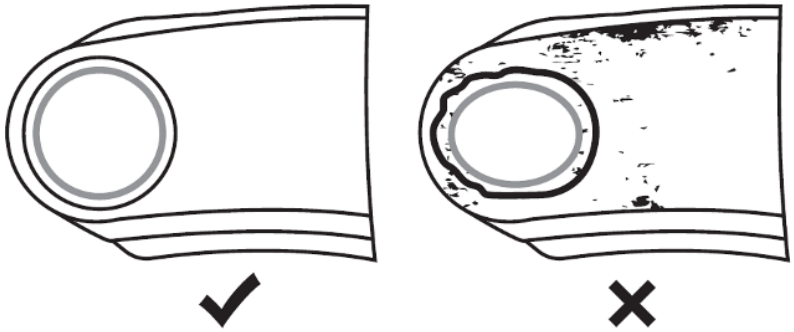
Figure 1.

- Before installation of ball joint, ensure all mating surfaces are clear of rust, debris and burrs. Inspect control arm mounting flange for cracks, deformation and or an out of round condition. Do not reuse control arm body if these are found. **See Figure 1**.

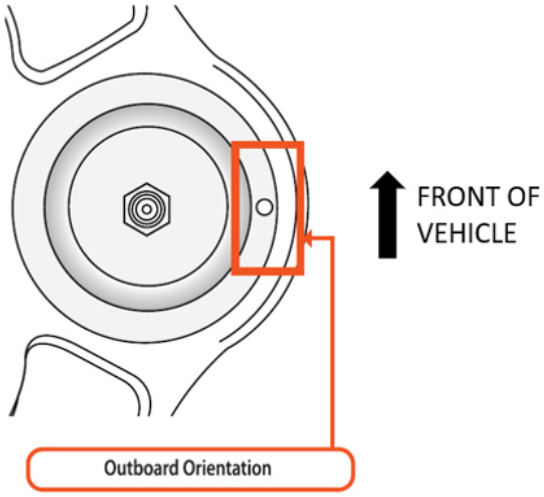
Figure 3. Correct ball joint installation orientation when mated to front upper control arm. Note drilled index mark position (highlighted orange box)

- During press-in, index mark must be oriented so that it is perpendicular to the wheel (facing outboard). For an illustration of correct installation orientation, **see Figure 3**.
