MEVOTECH INSIDER

Service Tips and Best Practices

Correct Installation Orientation: 2008-2004 Cadillac Sedan and CUV Front Upper Ball Joint

Brand	Supreme	Product	Ball Joint	Date	November 2022
Part Number(s)	MS50538

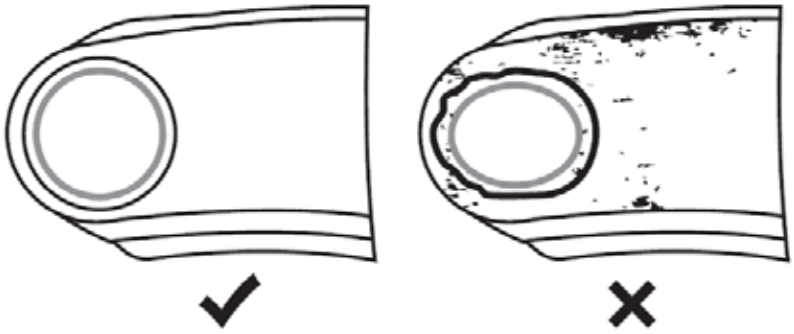
Figure 1.

- Before installation of ball joint, ensure all mating surfaces are clear of rust, debris and burrs. Inspect control arm mounting flange for cracks, deformation and or an out of round condition. Do not reuse control arm body if these are found. **See Figure 1**.
