# MEVOTECH INSIDER

Service Tips and Best Practices

## Correct Installation Orientation: 2015-2011 Dodge Durango and Jeep Grand Cherokee Front Upper Ball Joint

| Brand | Supreme | Product | Ball Joint | Date | July 2022 |

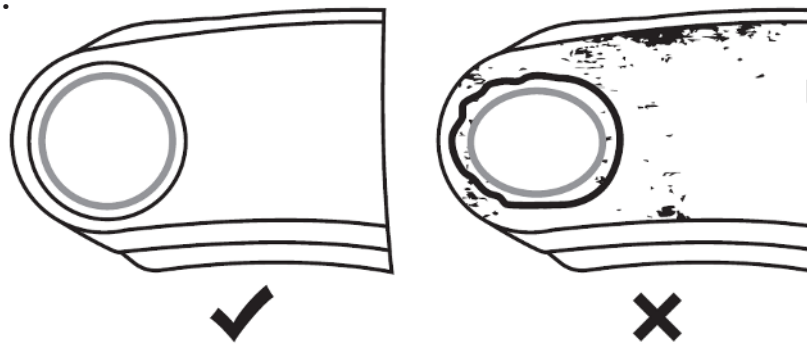
**Figure 1.**

- Before installation of ball joint, ensure all mating surfaces are clear of rust, debris and burrs. Inspect control arm mounting flange for cracks, deformation and or an out of round condition. Do not reuse control arm body if these are found. **See Figure 1**.

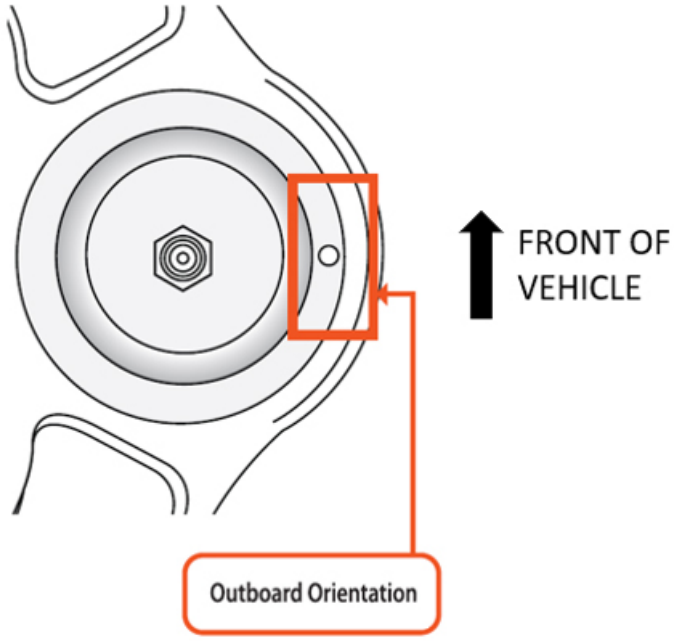
**Figure 3.** Correct ball joint installation orientation when mated to front upper control arm. Note drilled index mark position (highlighted orange box)

- During press-in, index mark must be oriented so that it is perpendicular to the wheel (facing outboard). For an illustration of correct installation orientation, **see Figure 3**.
