MEVOTECH INSIDER

Correct Installation Orientation: 2018-2007 Jeep Wrangler JK/JKU Front Lower Ball Joint

Brand	TTX	Product	Ball Joint	Date	September 2022
Part Number(s)	TXK3185

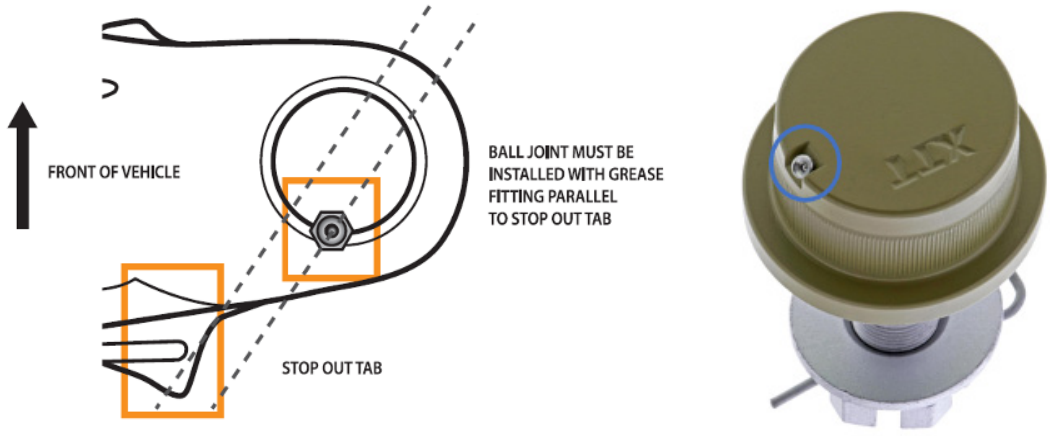
To ensure adequate access to the grease fitting, the below noted ball joint must be pressed-in using the correct orientation.

Figure 1. To ensure adequate clearance between components, ball joint must be installed with grease fitting parallel to lower stop out tab

- Before installation of ball joint, ensure all mating surfaces are clear of rust, debris and burrs.
- Verify press-in diameters and stud tolerances, including on steering knuckle side. Inspect mating surfaces for cracks, deformation and or an out of round condition. Replace all damaged or out-of-specification mating components.
- The ball joint must be installed with the grease fitting in parallel with the lower axle stop out tab. See Figure 1.
- Before press-in, it is recommended to create an index mark on both axle and ball joint housing using a suitable implement, such as a grease pencil. This will assist in attaining correct orientation during press-in.
