MEVOTECH INSIDER

Correct Installation Orientation: 2019-2014 GM 1500 Truck and SUV Front Lower Ball Joint

Brand	TTX	Product	Ball Joint	Date	March 2023
Part Number(s)	TXMS50532

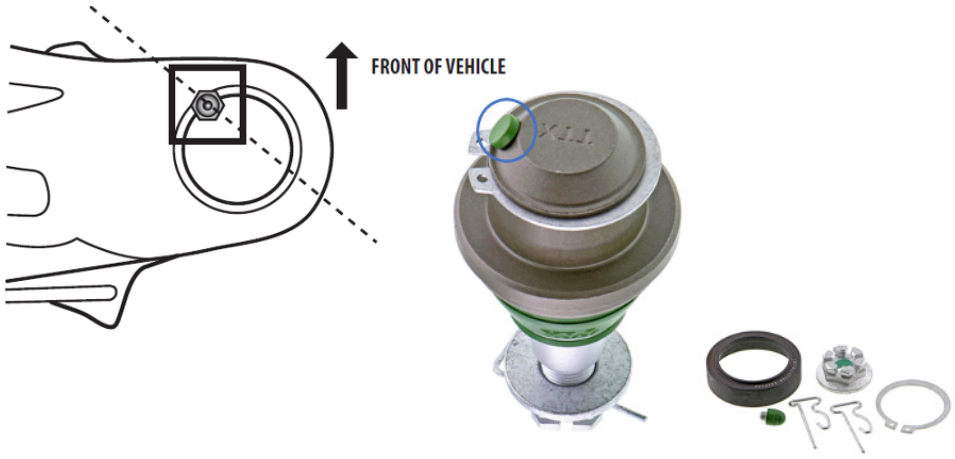
To ensure adequate access to the grease fitting for relubrication service, the below noted ball joint must be pressed-in using the correct orientation.

Figure 1. To ensure adequate clearance between components for relubrication service, ball joint must be installed with grease fitting positioned approximately 45° towards centerline of vehicle.

- Before installation of ball joint, ensure all mating surfaces are clear of rust, debris and burrs.
- Verify press-in diameters and stud tolerances, including on steering knuckle side. Inspect mating surfaces for cracks, deformation and or an out of round condition. Replace all damaged or out-of-specification mating components.
- Correct orientation is achieved when grease fi¬tting is located approximately 45° towards centerline of vehicle. Grease fitting must also be positioned towards front of vehicle. **See Figure 1.**
- Before press-in, it is recommended to create an index mark on both control arm and ball joint housing using a suitable implement, such as a grease pencil. This will assist in attaining correct orientation during press-in.
