MEVOTECH INSIDER

Correct Installation Orientation: 2019-2014 GM 1500 Truck & SUV Front Lower Ball Joint

Brand	Supreme	Product	Ball Joint	Date	March 2023
Part Number(s)	MS50532

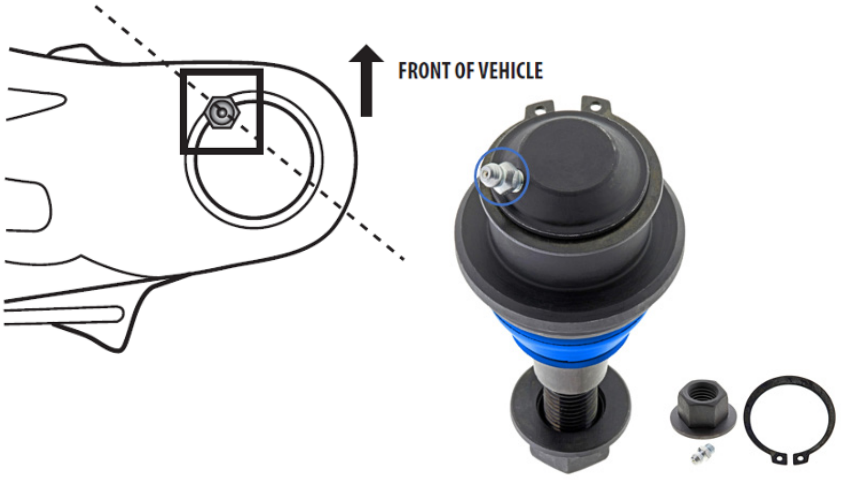
To ensure adequate access to the grease fitting for relubrication service, the below noted ball joint must be pressed-in using the correct orientation.

Figure 1. To ensure adequate clearance between components for relubrication service, ball joint must be installed with grease fitting positioned approximately 45° towards centerline of vehicle.

- Before installation of ball joint, ensure all mating surfaces are clear of rust, debris and burrs.
- Verify press-in diameters and stud tolerances, including on steering knuckle side. Inspect mating surfaces for cracks, deformation and or an out of round condition. Replace all damaged or out-of-specification mating components.
- Correct orientation is achieved when grease fi¬tting is located approximately 45° towards centerline of vehicle. Grease fitting must also be positioned towards front of vehicle. **See Figure 1**.
- Before press-in, it is recommended to create an index mark on both control arm and ball joint housing using a suitable implement, such as a grease pencil. This will assist in attaining correct orientation during press-in.
