MEVOTECH INSIDER
Service Tips and Best Practices

Correct Installation Orientation: 2021-1999 GM 2500-3500-4500 Van Front Upper Ball Joint

Brand	TTX	Product	Ball Joint	Date	March 2023
Part Number(s)	TXK6694

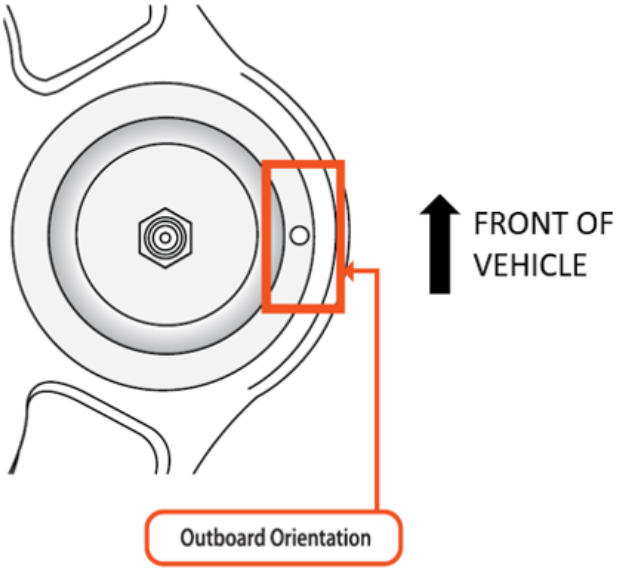
Figure 3. Correct ball joint installation orientation when mated to front upper control arm. Note drilled index mark position (highlighted orange box)

- During press-in, index mark must be oriented so that it is perpendicular to the wheel (facing outboard). For an illustration of correct installation orientation, **see Figure 3.**
