MEVOTECH INSIDER
Service Tips and Best Practices

Correct Installation Orientation: 2021-1999 GM 2500-3500-4500 Van Front Upper Ball Joint

Brand	Supreme	Product	Ball Joint	Date	March 2023
Part Number(s)	MK6694

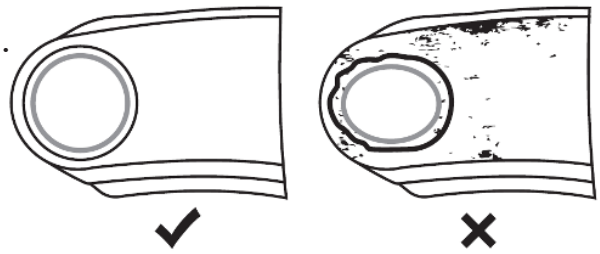
Figure 1.

- Before installation of ball joint, ensure all mating surfaces are clear of rust, debris and burrs. Inspect control arm mounting flange for cracks, deformation and or an out of round condition. Do not reuse control arm body if these are found. **See Figure 1.**

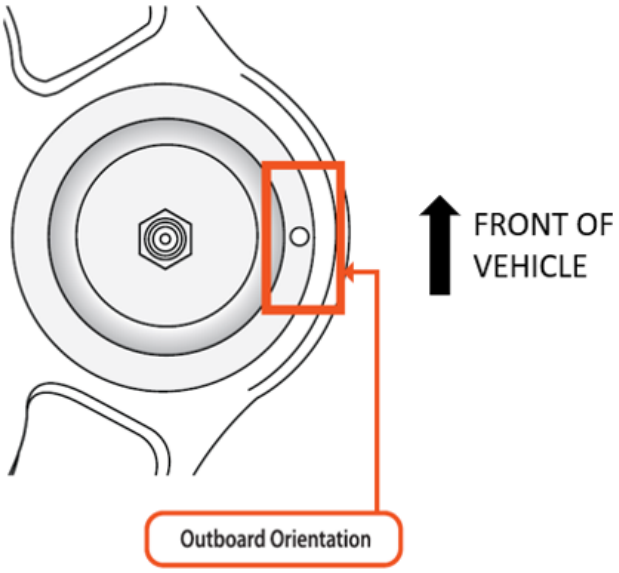
Figure 3. Correct ball joint installation orientation when mated to front upper control arm. Note drilled index mark position (highlighted orange box)

- During press-in, index mark must be oriented so that it is perpendicular to the wheel (facing outboard). For an illustration of correct installation orientation, **see Figure 3.**
