MEVOTECH INSIDER

Correct Installation Orientation: 2022-2014 RAM 2500 & 3500 Front Lower Ball Joint

Brand	Supreme	Product	Ball Joint	Date	September 2022
Part Number(s)	MS25532

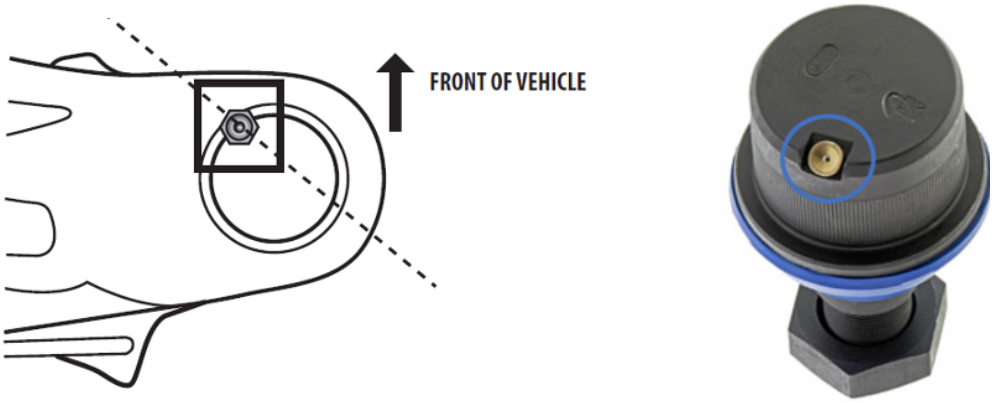
To ensure adequate access to the grease fitting for relubrication service, the below noted ball joint must be pressed-in using the correct orientation.

Figure 1. To ensure adequate clearance between components for relubrication service, ball joint must be installed with grease fitting positioned approximately 45° towards centerline of vehicle.

- Before installation of ball joint, ensure all mating surfaces are clear of rust, debris and burrs.
- Verify press-in diameters and stud tolerances, including on steering knuckle side. Inspect mating surfaces for cracks, deformation and or an out of round condition. Replace all damaged or out-of-specification mating components.
- Correct orientation is achieved when grease fitting is located approximately 45° towards centerline of vehicle. Grease fitting must also be positioned towards front of vehicle. **See Figure 1**.
- Before press-in, it is recommended to create an index mark on both axle and ball joint housing using a suitable implement, such as a grease pencil. This will assist in attaining correct orientation during press-in.
