MEVOTECH INSIDER

Correct Installation Orientation: 2022-2014 RAM 2500 and 3500 Front Lower Ball Joint

Brand	TTX	Product	Ball Joint	Date	September 2022
Part Number(s)	TXMS25532

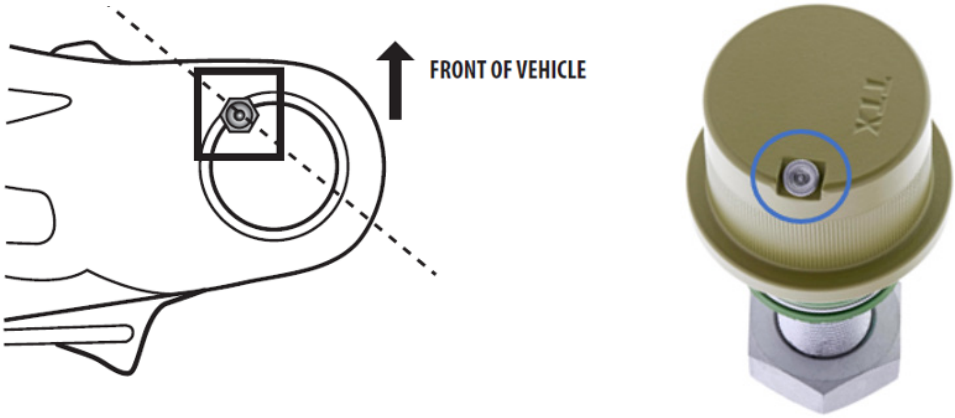
Figure 1. To ensure adequate clearance between components for relubrication service, ball joint must be installed with grease fitting positioned approximately 45° towards centerline of vehicle.

To ensure adequate access to the grease fitting for relubrication service, the below noted ball joint must be pressed-in using the correct orientation.

- Before installation of ball joint, ensure all mating surfaces are clear of rust, debris and burrs.
- Verify press-in diameters and stud tolerances, including on steering knuckle side. Inspect mating surfaces for cracks, deformation and or an out of round condition. Replace all damaged or out-of-specification mating components.
- Correct orientation is achieved when grease fitting is located approximately 45° towards centerline of vehicle. Grease fitting must also be positioned towards front of vehicle. **See Figure 1**.
- Before press-in, it is recommended to create an index mark on both axle and ball joint housing using a suitable implement, such as a grease pencil. This will assist in attaining correct orientation during press-in.
