TECHNICAL SERVICE BULLETIN

Addressing Memory Steer: Ford and Dodge Trucks with DANA 60 Axle

Issue: Ball Joint Replacement and Memory Steer on 4WD Dana 60 Axle Equipped Trucks

Publication:	TSB-20-017-01-01-E	**Product**	Ball Joints	**Date**	April 2020
Part Number(s)	Original Grade: GK80026, GK8607T Supreme:MK80026, MK8607T, MS40056 TTX: TXK80026, TXK8607T

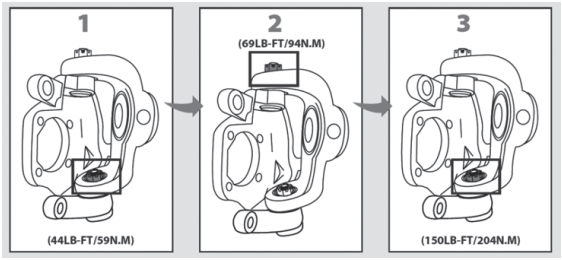
Figure 3

Installation Torque Sequence

1. Tighten lower ball stud nut to (44LB-FT/59N.M)
2. Tighten upper ball stud nut to (69LB-FT/94N.M)
3. Re-torque lower ball stud nut to (150LB-FT/204N.M)
   - Continue to tighten the nut to the next available slot. Never back off the nut to align hole in the stud for cotter pin insertion.
