MEVOTECH X-FACTOR BULLETIN

Major Design Improvement: 2017-2019 Chrysler Pacifica Front Lower Control Arms

Brand	Supreme	Product	Control Arms	Date	February 2021
Part Number(s)	CMS251239/CMS251240

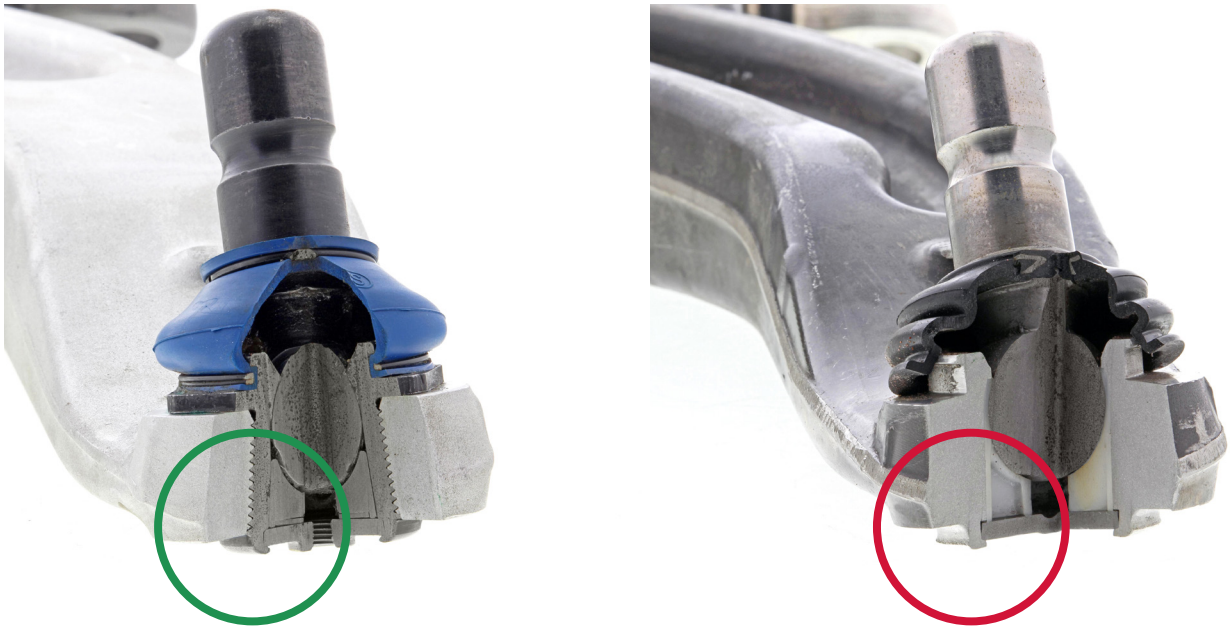
The OEM front lower control arm for the 2017-2019 Chrysler Pacifica is characterized by a non-greaseable plastic bearing.

Figure 1. Mevotech Bi-Metallic Technology sintered metal bearing (left) vs OE plastic bearing (right)

Mevotech Supreme front lower control arms feature sintered metal bearings which are greaseable for increased service life. This is made possible using patented Bi-Metallic Technology (US patent #8757648) which allows for a sintered metal ball joint to be threaded into an unitized aluminum control arm. **See Figure 1**. New hardware is provided for a complete install.

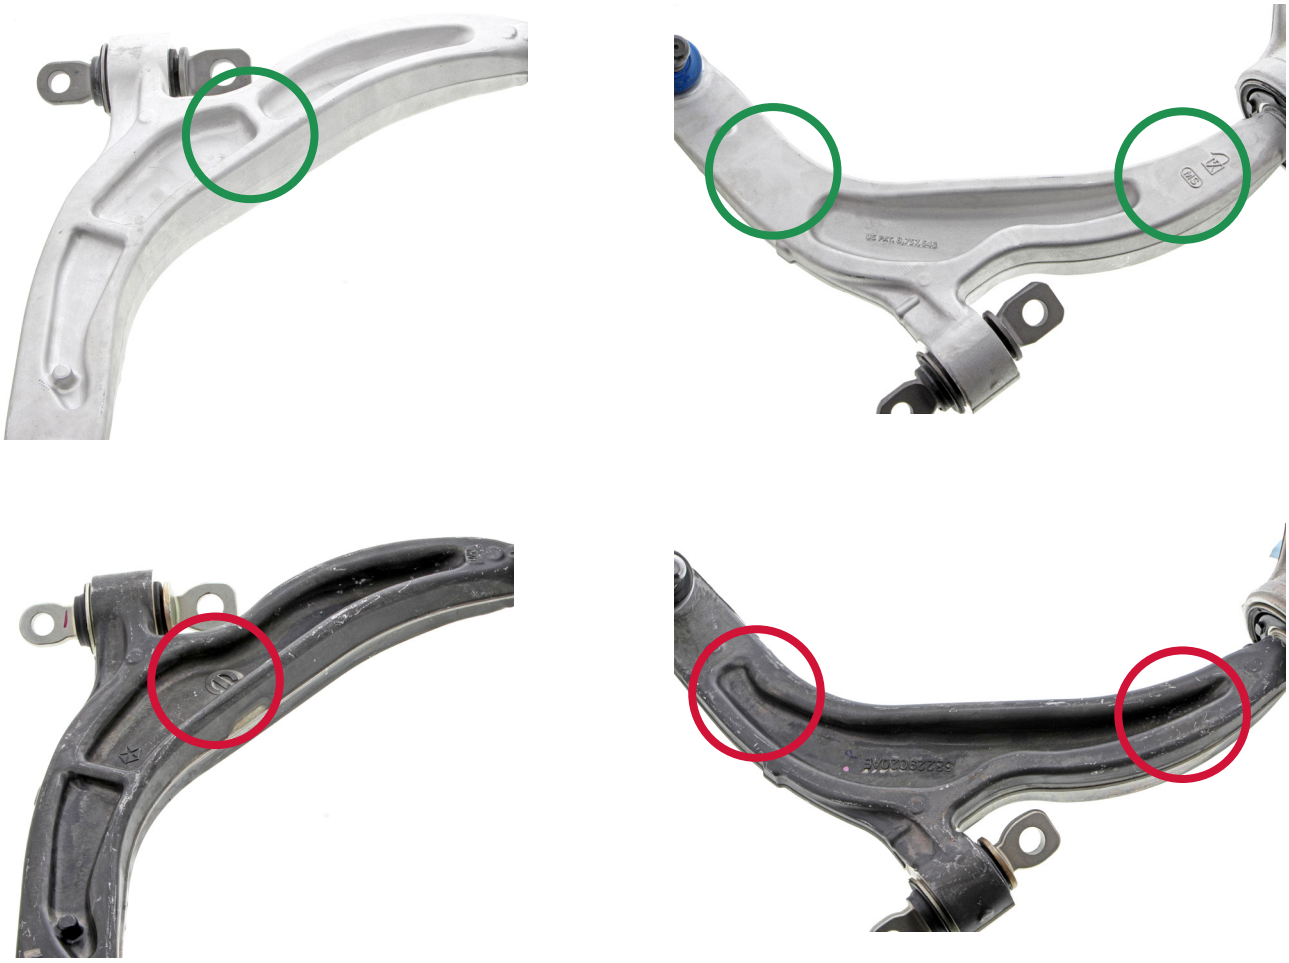
Figure 2. Mevotech additional cross-bracing and recesses filled in (top) vs OE forging profile (bottom).

Mevotech Supreme replacement front lower control arms improve the OEM forging profile through additional cross-bracing and by filling in recesses. **See Figure 2**.
