MEVOTECH INSIDER
Service Tips and Best Practices

Correct Installation Orientation: Jeep Wrangler JL/ JLU and Jeep Gladiator JT Front Lower Ball Joint

Brand	TTX	Product	Ball Joint	Date	September 2022
Part Number(s)	TXMS25575

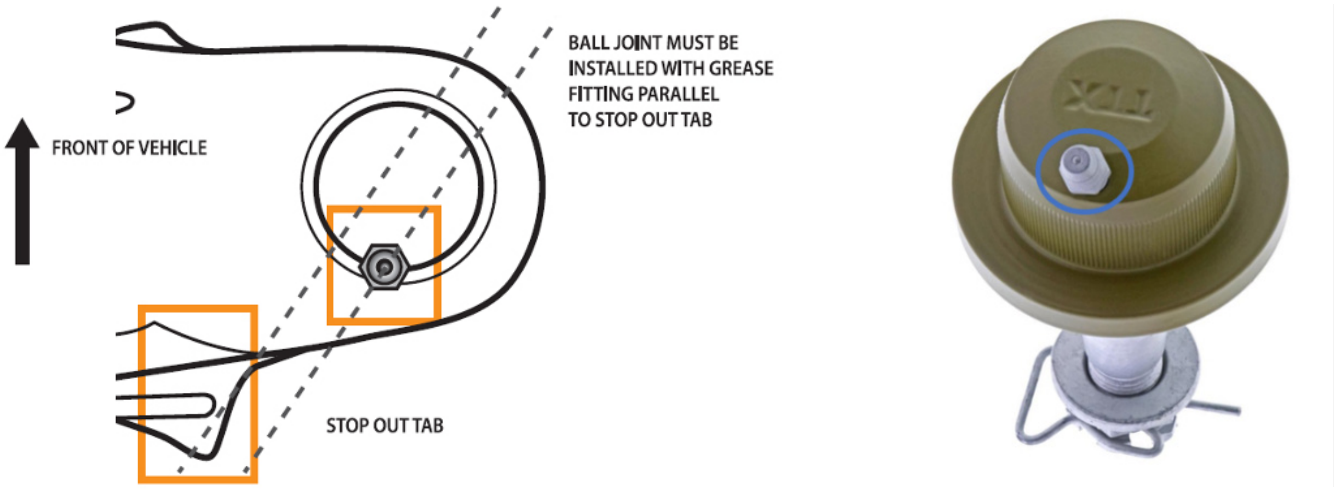
To ensure adequate access to the grease fitting, the below noted ball joint must be pressed-in using the correct orientation.

Figure 1. To ensure adequate clearance between components, ball joint must be installed with grease fitting parallel to lower stop out tab

- Before installation of ball joint, ensure all mating surfaces are clear of rust, debris and burrs.
- Verify press-in diameters and stud tolerances, including on steering knuckle side. Inspect mating surfaces for cracks, deformation and or an out of round condition. Replace all damaged or out-of-specification mating components.
- The ball joint must be installed with the grease fitting in parallel with the lower axle stop out tab. **See Figure 1**.
- It is recommended to test fit and verify orientation before and during press-in.
