MEVOTECH INSIDER
Service Tips and Best Practices

2006-1990 Jeep Front Lower Ball Joint: Correct Installation Orientation

Brand	TTX	Product	Ball Joint	Date	August 2021
Part Number(s)	TXK3161T

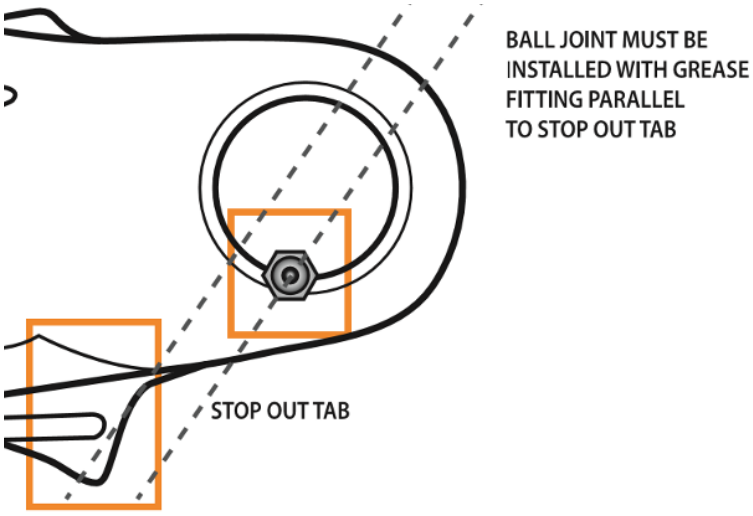
For the applications below, the ball joint housing must be oriented correctly during press in to ensure adequate access to the grease fitting for relubrication service.

The ball joint must be installed with the grease fitting positioned parallel to the lower knuckle stop out tab. This will ensure sufficient clearance for any relubrication service. **See Figure 1.**
