TECHNICAL SERVICE BULLETIN

Caster Change on Early Production Chrysler 300 & Dodge Challenger/Charger/Magnum Front Upper Control Arms

Issue: Replacement of Left and Right Control Arm at Same Time to Ensure Proper Alignment

Brand	Supreme & TTX	Product	Control Arms	Date	June 2020
Part Number(s)	CMS25117/CMS25118 & CTXMS25117/CTXMS25518

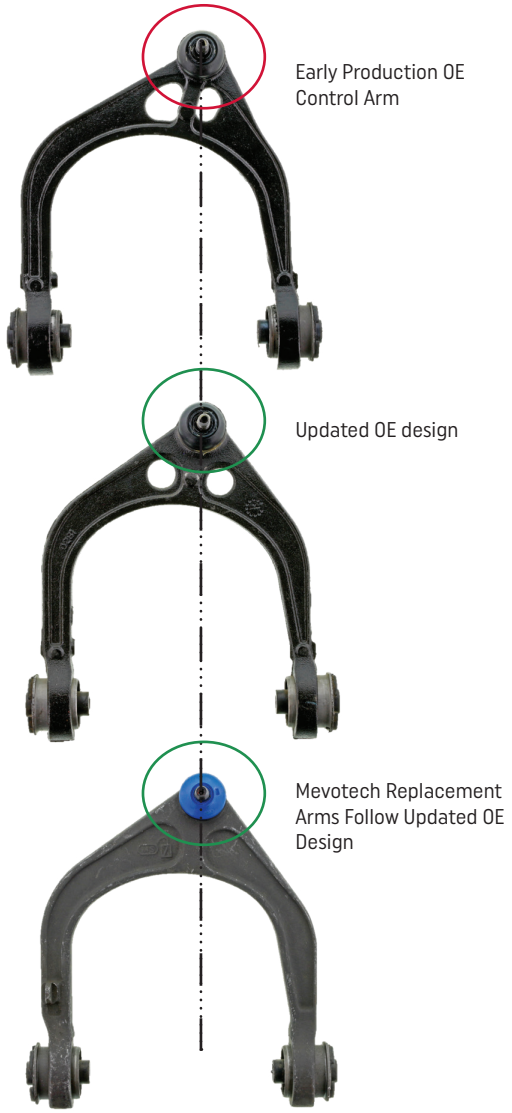
On early production models of the Chrysler 300 and Dodge Challenger/Charger/Magnum, FCA implemented a running design change on the front upper control arms.

This OE running design change is characterized by a revised caster setting for the front wheels. It is important to note that the caster setting variation is approximately 2°.

Do not mix the early production control arm design with the updated version. Mixing the design types may cause vehicle tracking issues, excessive tire wear and premature failure of the part.

When ordering replacement arms for these early production models, it is critical that both Front Upper Left and Right are replaced simultaneously.

After vehicle repair, perform alignment.
