MEVOTECH X-FACTOR BULLETIN

Labor Saver™: 2019-2011 GM 2500 HD & 3500 HD Truck Front Lower Ball Joint

Brand	TTX	Product	Ball Joint	Date	December 2022
Part Number(s)	TXMS50553

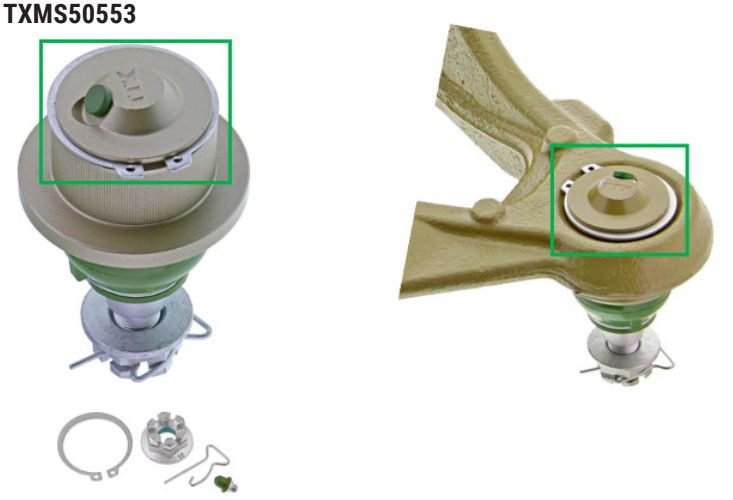
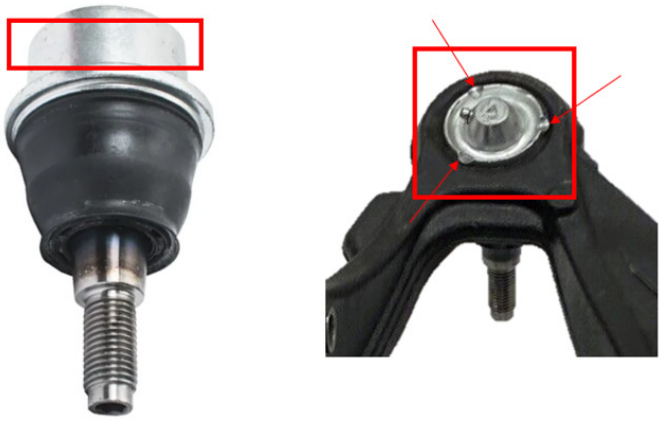
The OEM (PN: 19256656 and various other OE-style) front lower ball joints for the applications listed below require to be staked/crimped after press-in.

Figure 1. Mevotech TTX front lower ball joint TXMS50553 can be secured to the control arm easily via the included circlip (left) vs OEM stake/crimp method (right)

Mevotech TTX front lower ball joint TXMS50553 is engineered to utilize a circlip as the supplementary retention method. This reduces installation time for the Professional Technician and is a frustration-free alternative to the staking/crimping method. Additionally, the potential of damage to the control arm body is limited when securing the ball joint after press-in. **See Figure 1**.
