## 2010-2004 BMW X3 (E83/E83 LCI) - Front Lower Forward Control Arm and Front Lower Ball Joint Identification

<b>Brand</b>	Supreme	<b>Product</b>	Control Arm & Ball Joint	<b>Date</b>	January 2023
<b>Part Number(s)</b>	MS10501/MS10547/CMS10196/CMS10197

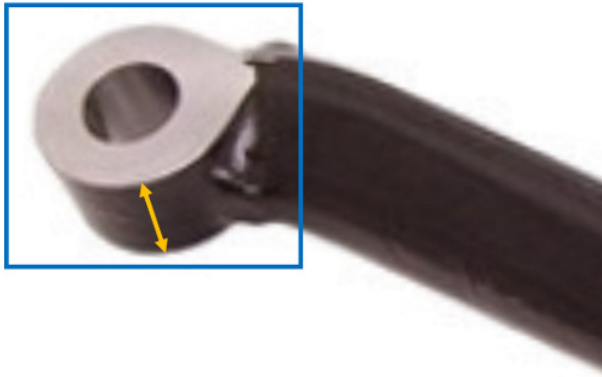
Vehicles built up to December 2006 (chassis code E83) and which still retain the original factory equipped components, will feature the original “thin” neck front lower forward control arms. This “thin” neck control arm can only be used in conjunction with a “shorter” height ball joint. **See Figure 1.**

**Figure 1.** First design “thin” neck front lower forward control arm

If replacing a “shorter” height ball joint on a vehicle with a production date up to December 2006 **and** which retains the original “thin” neck front lower forward control arm, use the following Mevotech Supreme part number:

**MS10501** - Front lower ball joint - “Shorter” height front lower ball joint for use in conjunction with “thin” neck front lower forward control arms
