2013-2007 Acura MDX and 2013-2010 Acura ZDX Front Lower Control Arm Compliance Bushing Bracket Nut

Brand	Supreme	Product	Control Arm	Date	August 2022
Part Number(s)	CMS601025/CMS601026

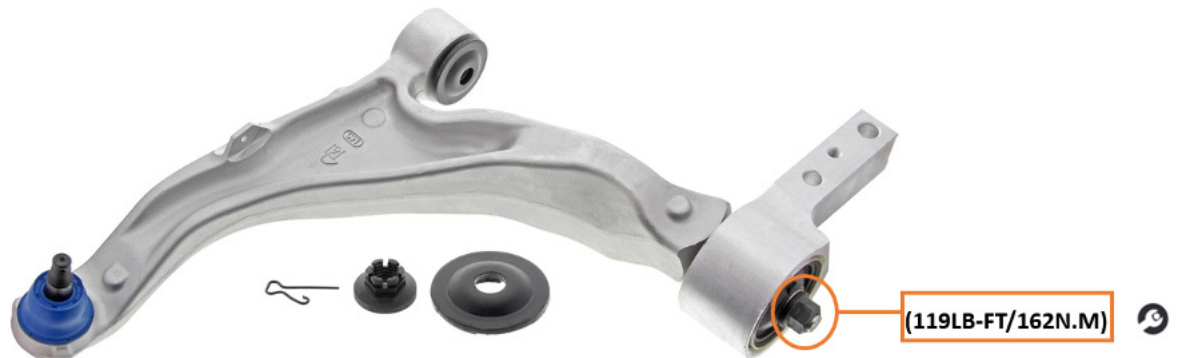
Figure 1. Bushing bracket nut (circled above) must be correctly torqued after fitting control arm to vehicle

When ordering Mevotech Supreme replacement front lower control arms with the part numbers CMS601025 and CMS601026 for the vehicle applications listed below, it is important for the Professional Technician to note that the bushing bracket nut is not pre-torqued out of the box. This bushing bracket is provided loose, so the bracket can more easily be manipulated during installation of the control arm. This nut will require final fastening with the proper torque value and suspension loaded to the correct ride height. **See Figure 1.**

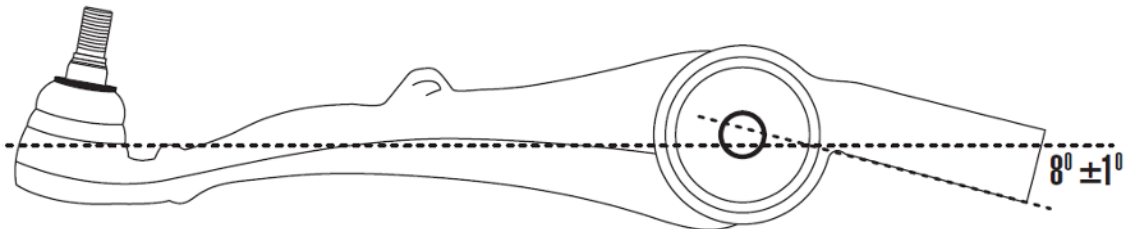
Figure 2. Correct installation orientation is achieved when center line of control arm and under edge of bracket are aligned within 8° (±1°).

It is also important to note that this bushing must be installed using the correct orientation. Correct orientation is achieved by aligning the center line of the control arm to the bottom edge of the bracket within 8° (±1°). **See Figure 2.**
