MEVOTECH INSIDER

2017-2010 Chevrolet Equinox and GMC Terrain Front Lower Control Arm Compliance Bushing Bracket Nut

Brand	TTX/Supreme/Original Grade		Product	Control Arm	Date	November 2021
Part Number(s)		CTXMS50117/CTXMS50118/MS50117/MS50118/GS50117/GS50118

Publication Number: MI-21-190-02-01-E

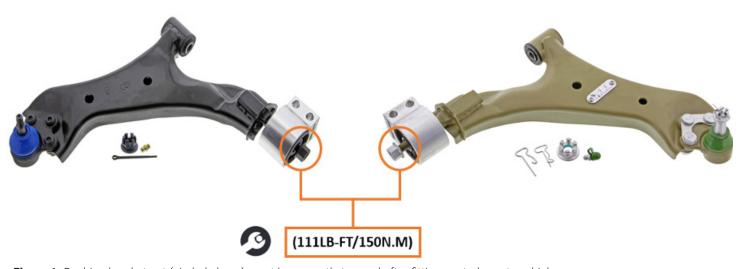
This nut is provided loose, so the bushing bracket can be more easily manipulated during installation of the control arm (**see Figure 1**). It will require final fastening with the proper torque value and suspension loaded to the correct ride height.

Figure 1. Bushing bracket nut (circled above) must be correctly torqued after fitting control arm to vehicle

When ordering Mevotech replacement front lower controls with the above-referenced part numbers for the vehicle applications listed below, it is important for the Professional Technician to note that the compliance bushing bracket nut is not pre-torqued out of the box.

Always refer to the factory service manual for correct diagnostic procedures, component removal and installation methods, as well as fastening torque values and procedures where applicable. Only use a calibrated torque wrench for final fastening.
