2020-2006 Ford F-250 SD & F-350 SD Pitman Arm to Sector Shaft Fastening Hardware

Brand	Supreme	Product	Pitman Arm	Date	September 2021
Part Number(s)	MS409122

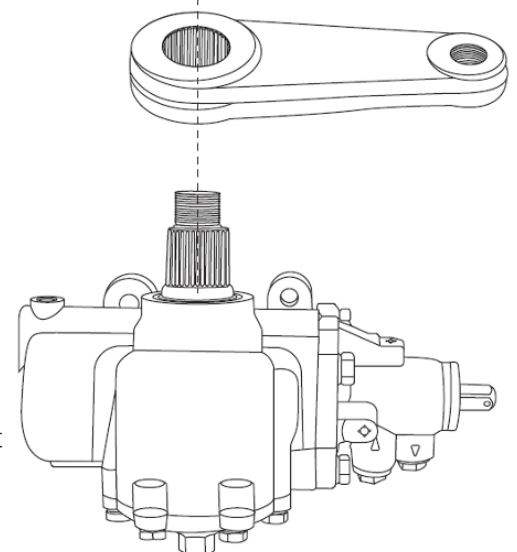
The OEM utilizes a 46 mm sector shaft nut to secure the pitman arm to the sector shaft on the applications below. The pitman arm to sector shaft is tapered and relies on a press fit, with the properly torqued nut providing compression between the two components and splines, ensuring no slippage occurs. **See Figure 1.**

Figure 1. Nut (orange highlight left) must be replaced when servicing pitman arm

The OEM requires this nut to be replaced once it is removed, due to degradation of the pre-applied dry adhesive and the high torque value required to achieve correct clamping force (350 lb-ft/475 N-m).

Reusing the old nut may cause it to “back off” and/or damage the splines on both the pitman arm and sector shaft due to slippage in the absence of the correct clamping force. The vehicle operator may also experience a “loose” steering feel.

- Note the correct installation orientation of the pitman arm before removal
- Thoroughly clean all threads and splines on the sector shaft and inspect them for damage and/or an out-of-specification condition. If damage is determined, replace steering box.
- Only use a new nut to mate pitman arm to sector shaft
- Refer to factory service manual for correct torque values and procedures
