Correct Installation Orientation: 2008-2004 Cadillac Sedan and CUV Front Upper Ball Joint

Brand	Supreme	Product	Ball Joint	Date	November 2022
Part Number(s)	MS50538

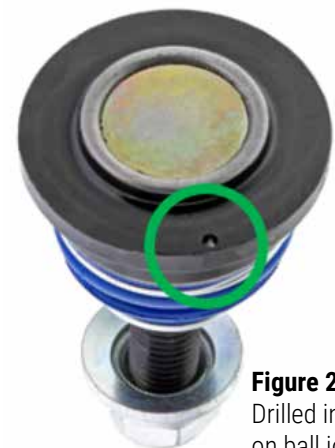
Figure 2.
Drilled index mark on ball joint flange (circled)

- Verify press-in diameters and stud tolerances, including on steering knuckle side. Replace all damaged or out-of-specification mating components.
- When pressing-in ball joint, ensure pressure is applied to the mounting flange and not the ball joint back plate. Contact with the back plate during install may lead to damage and or impaired performance of the ball joint.
- Locate drilled index mark on ball joint flange. **See Figure 2.**
- Before press-in, it is recommended to create an alignment mark on both control arm and ball joint housing using a suitable implement, such as a grease pencil. This will assist in attaining correct orientation during press-in.
