## Land Rover Rear Knuckle Upper and Lower Bushings

<b>Brand</b>	Supreme	<b>Product</b>	Bushings	<b>Date</b>	August 2021
<b>Part Number(s)</b>	Various

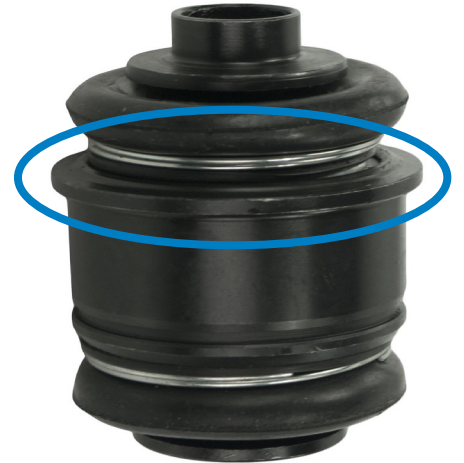
**Figure 2.** Ensure lip (circled) is correctly orientated during press-in

- After removing the worn bushing, remove all rust, burrs and other contaminants from the bore. Inspect the bore for abnormal wear, enlargement, “out of roundness” and/or other damage before installation. Replace knuckle if any of these conditions are found.
- Ensure correct orientation of replacement bushing during install. Generally, this will mean the mounting lip will face the front of the vehicle. **See Figure 2.**
- Renew hardware, such as snap rings and self-locking nuts.
- Ensure all components are torqued to the correct values. For most suspension repairs, Land Rover requires the vehicle to be in a particular service mode when performing the final torque sequence. Follow the correct torque procedure for the vehicle being repaired.
- After repair, perform a 4-wheel alignment.
