### Issue: 2018-1984 Jeep and RAM DANA 30/44 Front Upper Ball Joint Installation

<b>Brand</b>	Supreme/Original Grade	<b>Product</b>	Ball Joint	<b>Date</b>	October 2021
<b>Part Number(s)</b>	MK3134T/GK3134T

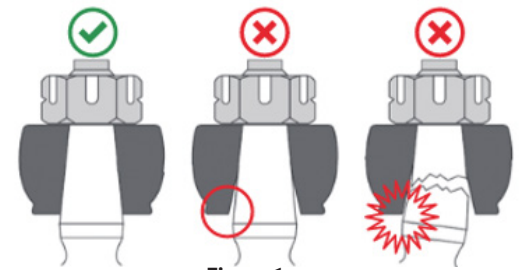
Figure 1.

- Ensure to check press-in diameters and tapered hole/stud tolerances. Replace all damaged or out-of-specification mating components.
- Remove all rust, burrs and corrosion from mating components.
- If a broken, bent or loose ball joint stud is discovered, the knuckle must be replaced. If there is deformation, an out-of-round condition or damage to the tapered mating surfaces of the steering knuckle, it must be replaced. **See Figure 1.**

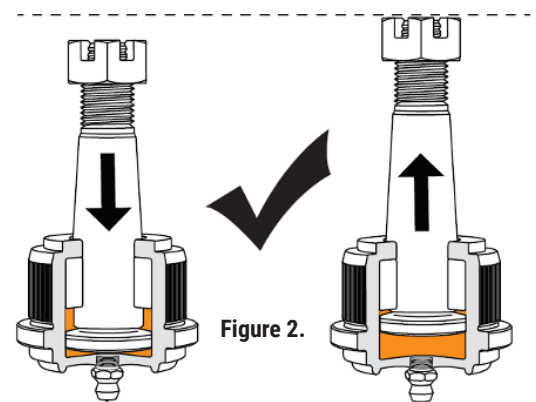
Figure 2.

- Mevotech Original Grade and Supreme Front Upper ball joints with the part numbers GK3134T and MK3134T both feature a telescoping movement (up and down) between the stud and housing to compensate for variation in the axle assembly. This is normal operation. **See Figure 2.**
- When pressing in ball joint, ensure pressure is applied to the mounting flange and not the ball joint back plate or lamination. Contact with either during installation may cause damage and limit part performance and service life.
- Depending on application, follow the torque sequence as outlined in **Figure 3.** It is recommended to perform this sequence with the steering knuckle in the straight-ahead position. This ensures steering knuckle is properly aligned to the axle assembly. The final position of the ball joint will be set by following the torque sequence.
