Labor Saver™: 2009-2005 Nissan 350Z and 2007-2005 Infiniti G35 Front Lower Forward Control Arm Tapered Sleeve

Brand	Supreme	Product	Control Arm	Date	November 2022
Part Number(s)	CMS301030/CMS301031

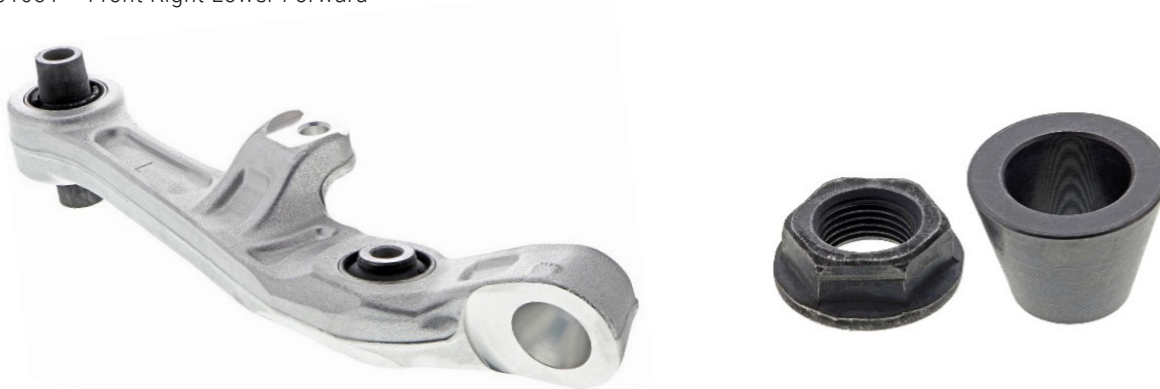
Figure 1. Mevotech Supreme front lower forward control arms for the 2009-2005 Nissan 350Z and 2007-2005 Infiniti G35 RWD feature a new tapered sleeve and ball joint to control arm nut as part of the hardware package, saving time and providing more value in a repair option for the Professional Technician

The below noted Mevotech Supreme front lower forward control arms include a new anti-corrosion coated sleeve for a frustration-free installation. **See Figure 1.**
